TECHNICAL NOTE 3190

FATIGUE INVESTIGATION OF FULL-SCALE
TRANSPORT-AIRPLANE WINGS

SUMMARY OF CONSTANT-AMPLITUDE TESTS THROUGH 1953

By M. J. McGuigan, Jr., D. F. Bryan, and R. E. Whaley

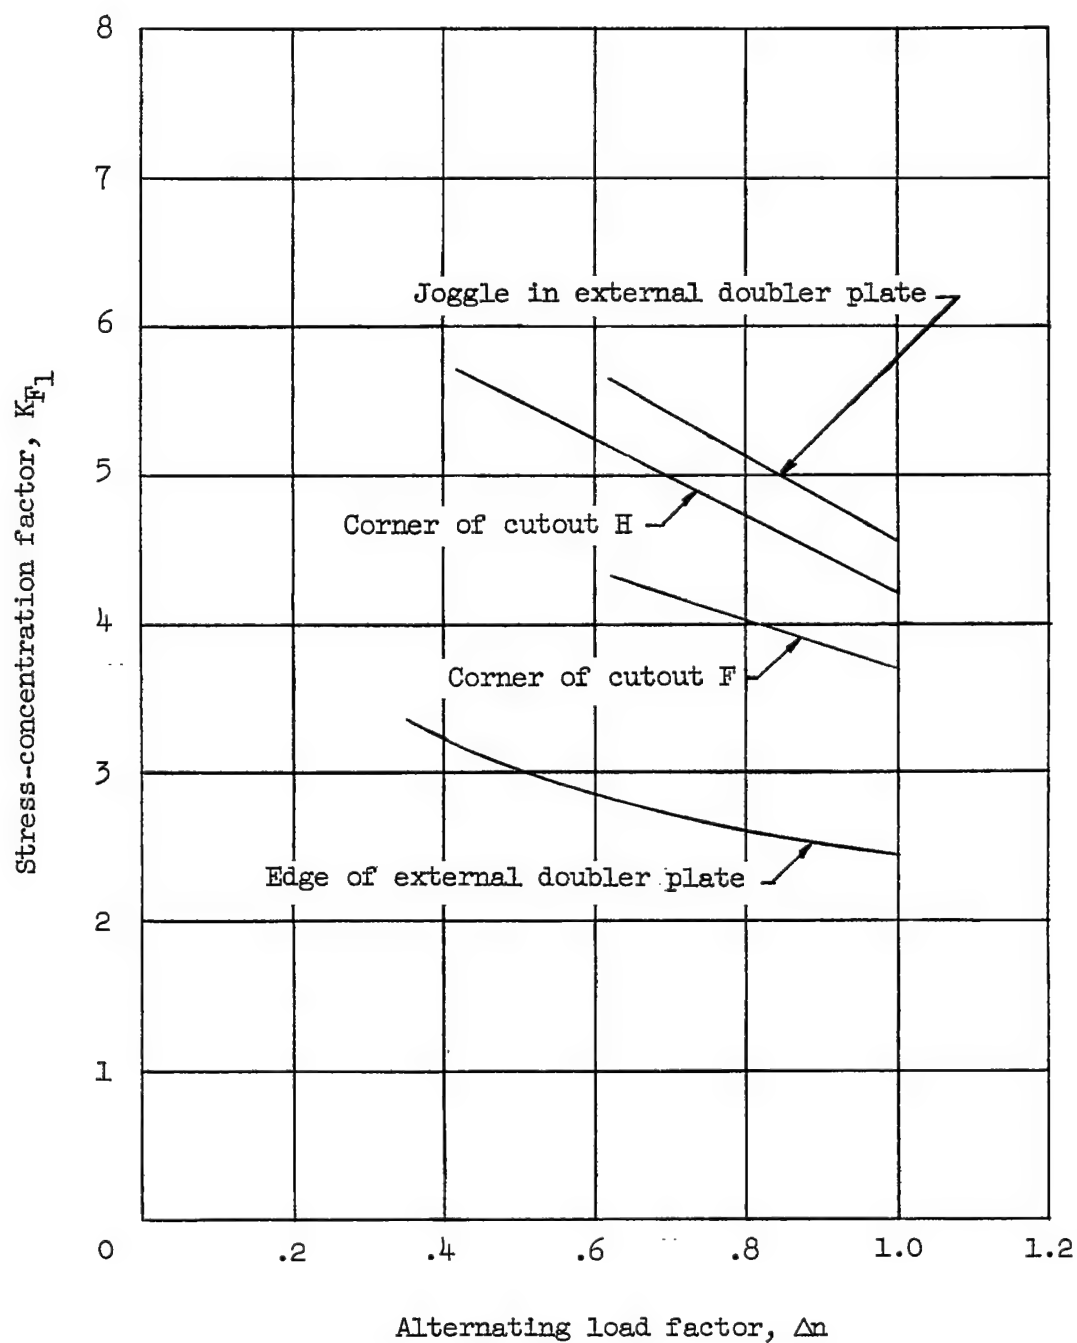
Figure 10.- Effect of load level on the stress-concentration factor.

The range of concentration factor K_{F1} occurring at each load level for the five types of failures is shown in table 2. It can be noted from this table that the concentration factor tends to decrease with increasing load level. This trend is shown graphically in figure 10 for several locations where failures occurred at more than one load level. The trend is assumed to be caused by the increasing effects of plasticity associated with higher stresses as the load level is increased. Both K_{F2} and K_{F3} show the same decreasing trend with increasing load level that K_{F1} does, but in the case of K_{F3} the trend is not very apparent because of the lower magnitudes involved.
